# SIMULATED HAIL DAMAGE AND IMPACT RESISTANCE TEST PROCEDURES

For Roof Coverings and Membranes

BY VICKIE CRENSHAW AND JIM D. KOONTZ, P.E.

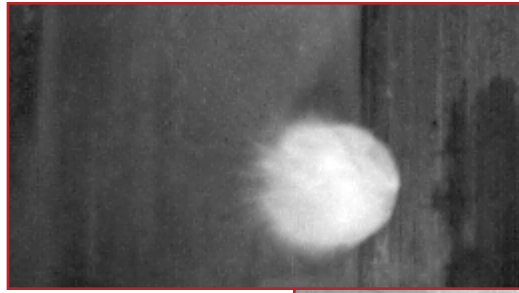
Left: Photo 2. Ice Sphere at Moment of Impact with Concrete Tile.

The answer to the technical question of why some roofing systems fail when impacted with steel versus ice is relatively simple. The ice spheres will compress or crush upon impact with a very hard surface such as concrete tile. Photo 2 depicts an ice sphere at the moment of impact with a concrete tile. A slight crushing of the ice is seen to occur at the surface of the sphere.
